SWAN VALLEY IRRIGATION SCHEME MELROSE DAM - TASMANIA

Foundation Grouting

Melrose Dam Foundation drilling and grouting

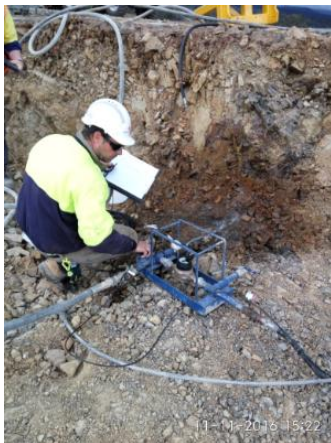
Water Pressure Test

Menard completed 1500lm of drilling, 295 no of water pressure test hook up and injection of 16,000 L of grout in less than 4 weeks - 2 weeks in advance of the construction programme.

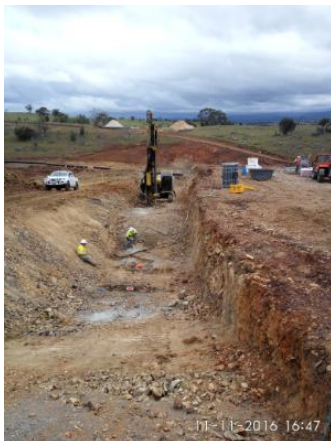
Drilling and Grouting in dam key way
